**Flood Control Project Maintenance
Levee Inspections**
LMA District Cover Sheet
Spring 2019 Levee Inspection Results

Spring 2019 Levee Inspection Results

Sutter Maintenance Yard Hamilton Bend

Waterway			Bank	Unit Miles
Unit No. 01 Feather River Hamilton Bend			Right	3.39
	Spring (March - May)	Summer (June - August)	(September - November) Fall	Winter (December - February)
Unit Maintenance Rating (Fall Only)				
Date of Inspection	4/4/2019 - 4/4/2019			
DWR Inspector	Sterling York			
Accompanied By	Shawn Freitag Sutter Maintenance Yard

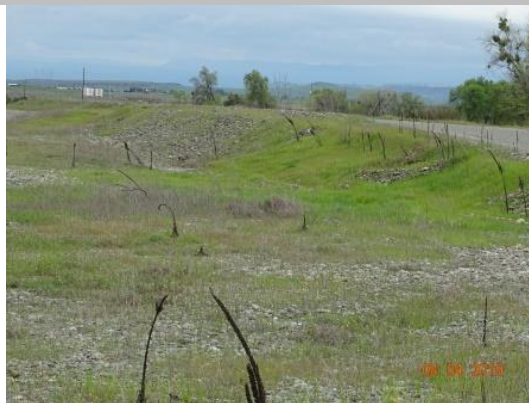
Photo 1 of 1 : SP_2019_ST0005_289_3_20190409_00016.jpg

LM Start	0.00	Rating **	A	Issue No.	3
LM End	1.37	Issue Type +	Ma	Location *	LS
Category	Earthen Levee			GPS Latitude/Longitude	
				Start	End
Item	Vegetation			39.439671 °	39.457917 °
				-121.641410 °	-121.638319 °
DWR ID	DWR_ST0005_01_s_2019_3				
Comment Code					
V1 : Control annual grass and weeds on the levee slopes and easements.					
Inspector Comment					
From levee mile 0.00 to levee mile 1.37 the annual vegetation is well maintained, Spring 2019.

View looking upstream landside from levee mile 0.00 to levee mile 1.37 where annual vegetation is well maintained, Spring 2019.

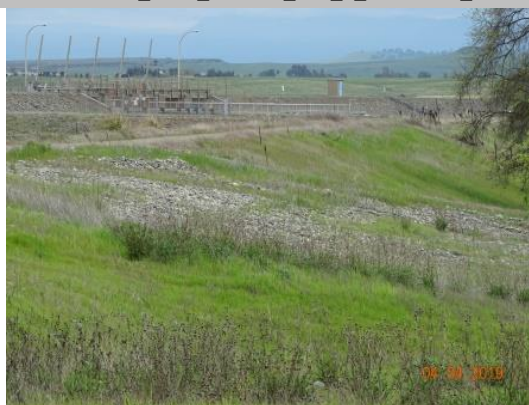
Photo 1 of 1 : SP_2019_ST0005_289_5_20190409_00015.jpg

LM Start	0.00	Rating **	A	Issue No.	5
LM End	1.37	Issue Type +	Ma	Location *	WS
Category	Earthen Levee			GPS Latitude/Longitude	
				Start	End
Item	Vegetation			39.439671 °	39.457917 °
				-121.641410 °	-121.638319 °
DWR ID	DWR_ST0005_01_s_2019_5				
Comment Code					
V1 : Control annual grass and weeds on the levee slopes and easements.					
Inspector Comment					
From levee mile 0.00 to levee mile 1.37 the annual vegetation is well maintained, Spring 2019.

View looking upstream waterside from levee mile 0.00 to levee mile 1.37 where annual vegetation is well maintained, Spring 2019.

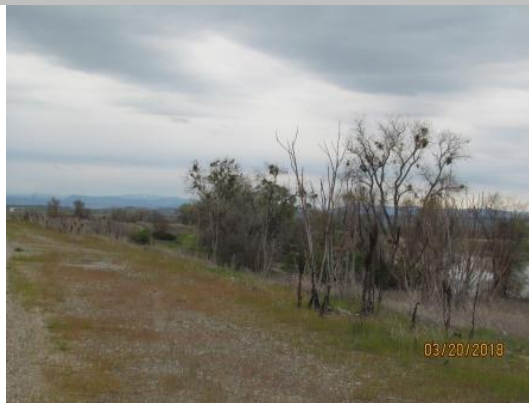
Photo 1 of 1 : SP_2019_ST0005_289_14_20190305_00005.jpg

LM Start	0.73	Rating **	A	Issue No.	14
LM End	0.91	Issue Type +	Ma	Location *	WS
Category	Earthen Levee			GPS Latitude/Longitude	
				Start	End
Item	Trim / Thin Trees			39.450109 °	39.452643 °
				-121.640851 °	-121.640316 °
DWR ID	DWR_ST0005_01_s_2016_14				
Comment Code					
T3 : Trim and thin trees to allow visibility of the ground and room to flood fight.					
Inspector Comment					
Small trees 4" in diameter at chest height have been sprayed and should be removed, Fall 2018.

View looking upstream waterside of trees. Small trees 4" in diameter at chest height have been sprayed and should be removed, Spring 2018.

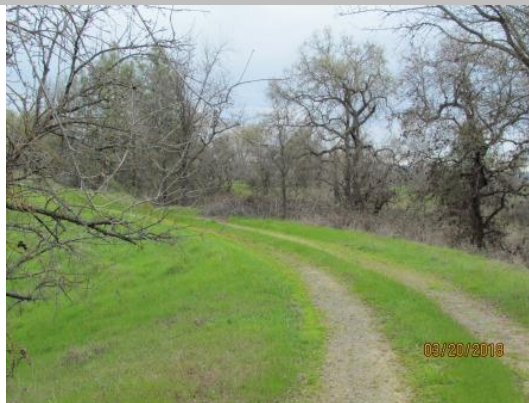
Photo 1 of 1 : SP_2019_ST0005_289_18_20190305_00007.jpg

LM Start	1.48	Rating **	U	Issue No.	18
LM End	1.99	Issue Type +	Ma	Location *	WS
Category	Earthen Levee			GPS Latitude/Longitude	
				Start	End
Item	Trim / Thin Trees			39.458053 °	39.461949 °
				-121.636300 °	-121.629563 °
DWR ID	DWR_ST0005_01_s_2017_18				
Comment Code					
T3 : Trim and thin trees to allow visibility of the ground and room to flood fight.					
Inspector Comment					
Trim/Thin Trees from Levee Mile 1.48 to 1.99. The LMA does not maintain the levee from Levee Mile 1.38 to 3.39.

View looking upstream of thick trees and vegetation blocking visibility on waterside, looking downstream. Spring 2018.

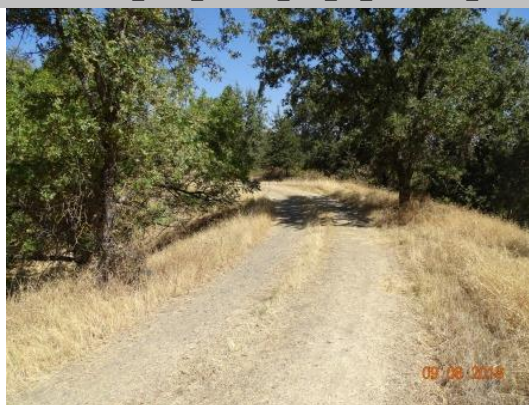
Photo 1 of 1 : SP_2019_ST0005_289_11_20190305_00004.jpg

LM Start	1.48	Rating **	U	Issue No.	11
LM End	3.25	Issue Type +	Ma	Location *	LS
Category	Earthen Levee			GPS Latitude/Longitude	
				Start	End
Item	Trim / Thin Trees			39.458055 °	39.470312 °
				-121.636300 °	-121.609242 °
DWR ID	DWR_ST0005_01_s_2017_11				
Comment Code					
T3 : Trim and thin trees to allow visibility of the ground and room to flood fight.					
Inspector Comment					
Trim/Thin Trees from Levee Mile 1.48 to 3.25. The LMA does not maintain the levee from Levee Mile 1.38 to 3.39.

View looking upstream landside and waterside of thick trees blocking visibility on landside, Fall 2018.

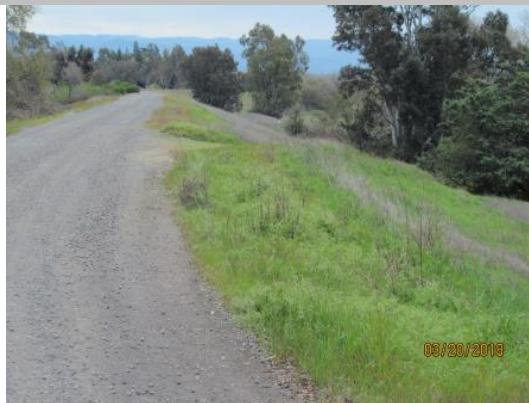
Photo 1 of 1 : SP_2019_ST0005_289_17_20190305_00006.jpg

LM Start	1.50	Rating **	U	Issue No.	17
LM End	1.96	Issue Type +	Ma	Location *	WS
Category	Earthen Levee			GPS Latitude/Longitude	
				Start	End
Item	Vegetation			39.458131 °	39.461634 °
				-121.635916 °	-121.629926 °
DWR ID	DWR_ST0005_01_f_2017_17				
Comment Code					
V2 : Remove the wild growth other than native grasses from the levee slopes.					
Inspector Comment					
Maintain annual grasses from Levee Mile 1.50 to 1.96. The LMA does not maintain the levee from Levee Mile 1.38 to 3.39.

View looking upstream waterside of annual grasses that need to be maintained, Spring 2018.

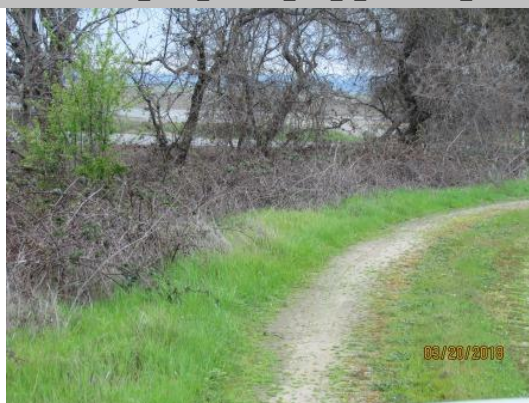
Photo 1 of 1 : SP_2019_ST0005_289_6_20190305_00002.jpg

LM Start	1.50	Rating **	U	Issue No.	6
LM End	2.63	Issue Type +	Ma	Location *	LS
Category	Earthen Levee			GPS Latitude/Longitude	
				Start	End
Item	Vegetation			39.458132 °	39.466025 °
				-121.635914 °	-121.618972 °
DWR ID	DWR_ST0005_01_f_2016_6				
Comment Code					
V2 : Remove the wild growth other than native grasses from the levee slopes.					
Inspector Comment					
Blackberries covering slope from Levee Mile 1.50 to 2.63. The LMA does not maintain the levee from Levee Mile 1.38 to 3.39.

View looking upstream landside of blackberries that are covering the landside slope, Spring 2018.

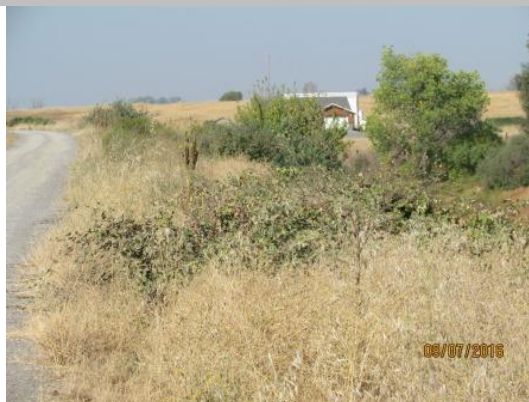
Photo 1 of 1 : SP_2019_ST0005_289_10_20190305_00003.jpg

LM Start	2.46	Rating **	U	Issue No.	10
LM End	2.48	Issue Type +	Ma	Location *	LS
Category	Earthen Levee			GPS Latitude/Longitude	
				Start	End
Item	Vegetation			39.465370 °	39.465410 °
				-121.622074 °	-121.621736 °
DWR ID	DWR_ST0005_01_f_2016_10				
Comment Code					
V2 : Remove the wild growth other than native grasses from the levee slopes.					
Inspector Comment					
Blackberries covering slope from Levee Mile 2.46 to 2.48. The LMA does not maintain the levee from Levee Mile 1.38 to 3.39.

View of blackberries that are covering landside slope.

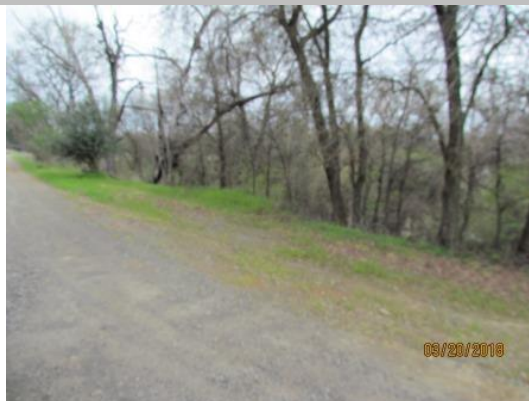
Photo 1 of 1 : SP_2019_ST0005_289_4_20190305_00001.jpg

LM Start	3.23	Rating **	U	Issue No.	4
LM End	3.27	Issue Type +	Ma	Location *	WS
Category	Earthen Levee			GPS Latitude/Longitude	
				Start	End
Item	Trim / Thin Trees			39.470063 °	39.470558 °
				-121.609264 °	-121.609215 °
DWR ID	DWR_ST0005_01_s_2013_4				
Comment Code					
T3 : Trim and thin trees to allow visibility of the ground and room to flood fight.					
Inspector Comment					
Small trees 4" in diameter at chest height should be removed before they get too big from Levee Mile 3.23 to 3.27. Levee Mile 1.38 to 3.39 has never been maintained by the LMA.

View looking upstream waterside of small trees 4" in diameter at chest height should be removed before they get to big, Spring 2018.

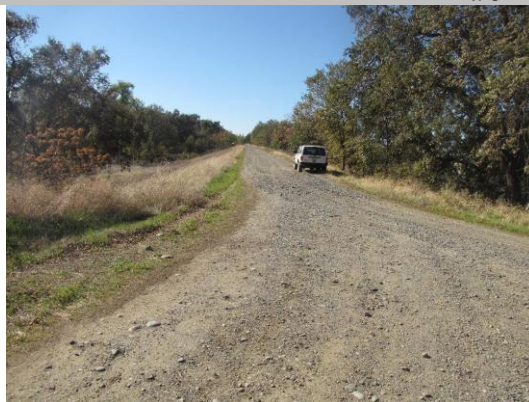
Photo 1 of 3 : UCIP_SP_2019_53941_21682.jpg

Comment Code						
Inspector Comment						
FS_ID:53941 DS_ID:17044 EP_NO: N/A Repair Type: Non-Urgent Crossing Status: Indicator Found UCIP Comments: 05/07/2019 (O. Magana - DWR UCIP)04/26/2016 Unable to access area near structure.05/14/2013 Same as last inpection.11/14/2012 Abandoned Structure: WS- reminince of gates and concrete standpipe; LS-reminince of concrete headwall and pump station. FIELD_STRUCT_DESC: *ABANDONED* [Western Canal Head Gate Inlet Structure] 1 of 2: 96-inch by 96-inch (8-foot by 8-foot) reinforced concrete culverts through the levee 25 feet below the crown. Three slide gates on the waterside (WS) end. Concrete stairs on the WS slope. Concrete headwall at both WS and landside (LS) toes. [Additional Reference(s): DWR Levee Log, 2005. USACE Sacramento O&M Manual 152, March 1957 (Station 170+00)] FS Date: 5/7/2019 12:36:41 PM

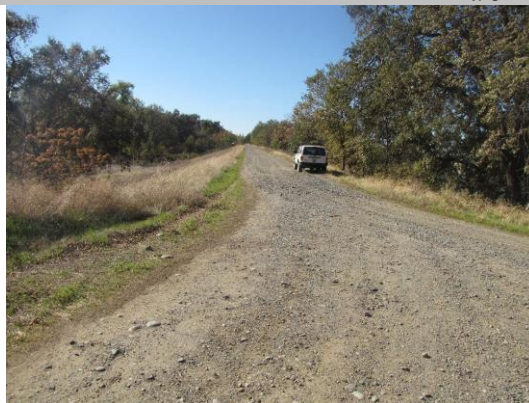
Photo 1 of 3 : UCIP_SP_2019_53942_21697.jpg

FS_ID:53942
DS_ID:17056
EP_NO: N/A
Repair Type: Non-Urgent
Crossing Status: Indicator Found
UCIP Comments: 05/07/2019 (O. Magana - DWR UCIP)04/26/2016
Unable to access area near structure.05/14/2013 Same as last inspection.11/14/2012 Abandoned Structure: WS- reminince of gates and concrete standpipe; LS-reminince of concrete headwall and pump station.
FIELD_STRUCT_DESC: *ABANDONED* [Western Canal Head Gate Inlet Structure] 2 of 2: 72-inch by 96-inch (8-foot by 8-foot) reinforced concrete culvert through the levee 25 feet below the crown. Three slide gates on the waterside (WS) end. Concrete stairs on the WS slope. Concrete headwall at both toes. [Additional Reference(s): DWR Levee Log, 2005. USACE Sacramento O&M Manual 152, March 1957 (Station 170+00)]
FS Date: 5/7/2019 12:37:43 PM

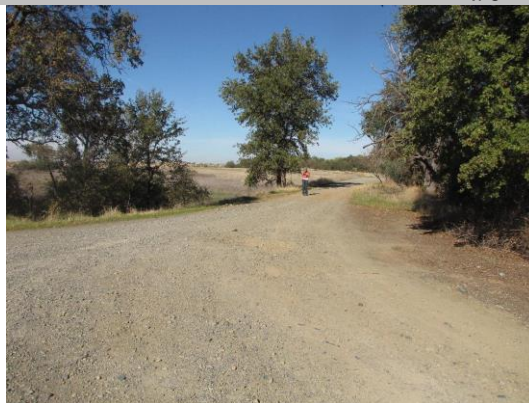
Photo 3 of 3 : UCIP_SP_2019_53942_21695.jpg

Comment Code						
Inspector Comment						
FS_ID:53942 DS_ID:17056 EP_NO: N/A Repair Type: Non-Urgent Crossing Status: Indicator Found UCIP Comments: 05/07/2019 (O. Magana - DWR UCIP)04/26/2016 Unable to access area near structure.05/14/2013 Same as last inspection.11/14/2012 Abandoned Structure: WS- reminince of gates and concrete standpipe; LS-reminince of concrete headwall and pump station. FIELD_STRUCT_DESC: *ABANDONED* [Western Canal Head Gate Inlet Structure] 2 of 2: 72-inch by 96-inch (8-foot by 8-foot) reinforced concrete culvert through the levee 25 feet below the crown. Three slide gates on the waterside (WS) end. Concrete stairs on the WS slope. Concrete headwall at both toes. [Additional Reference(s): DWR Levee Log, 2005. USACE Sacramento O&M Manual 152, March 1957 (Station 170+00)] FS Date: 5/7/2019 12:37:43 PM
